Double glass component broken

Overview

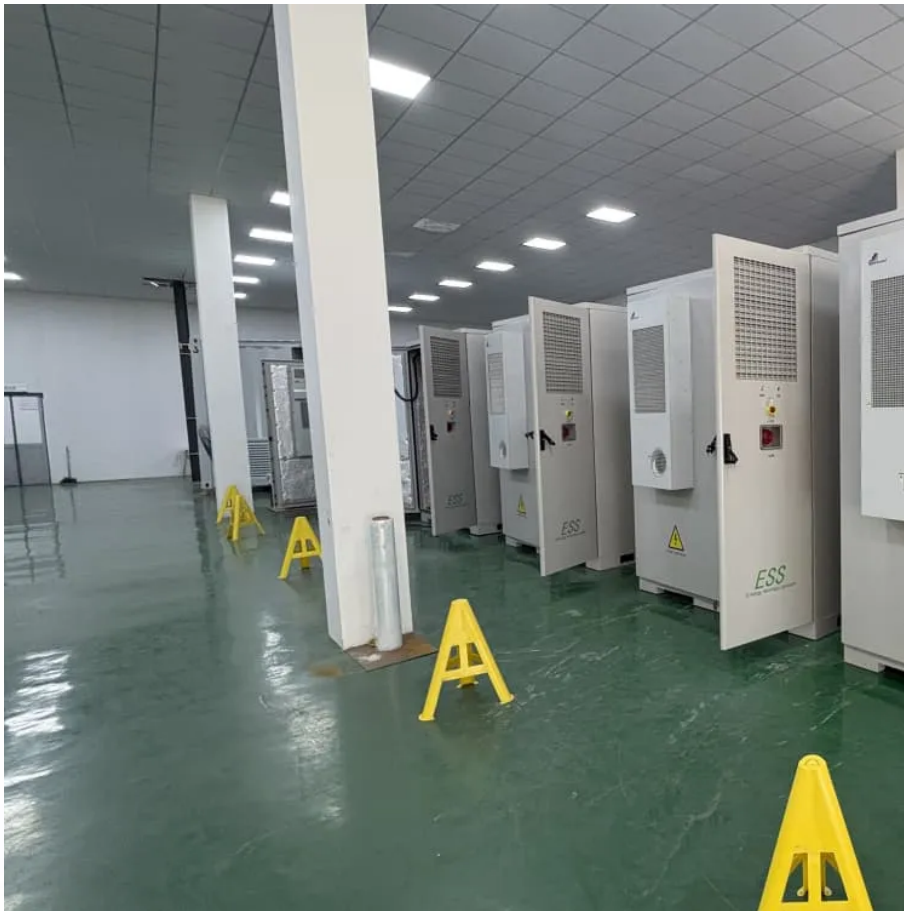
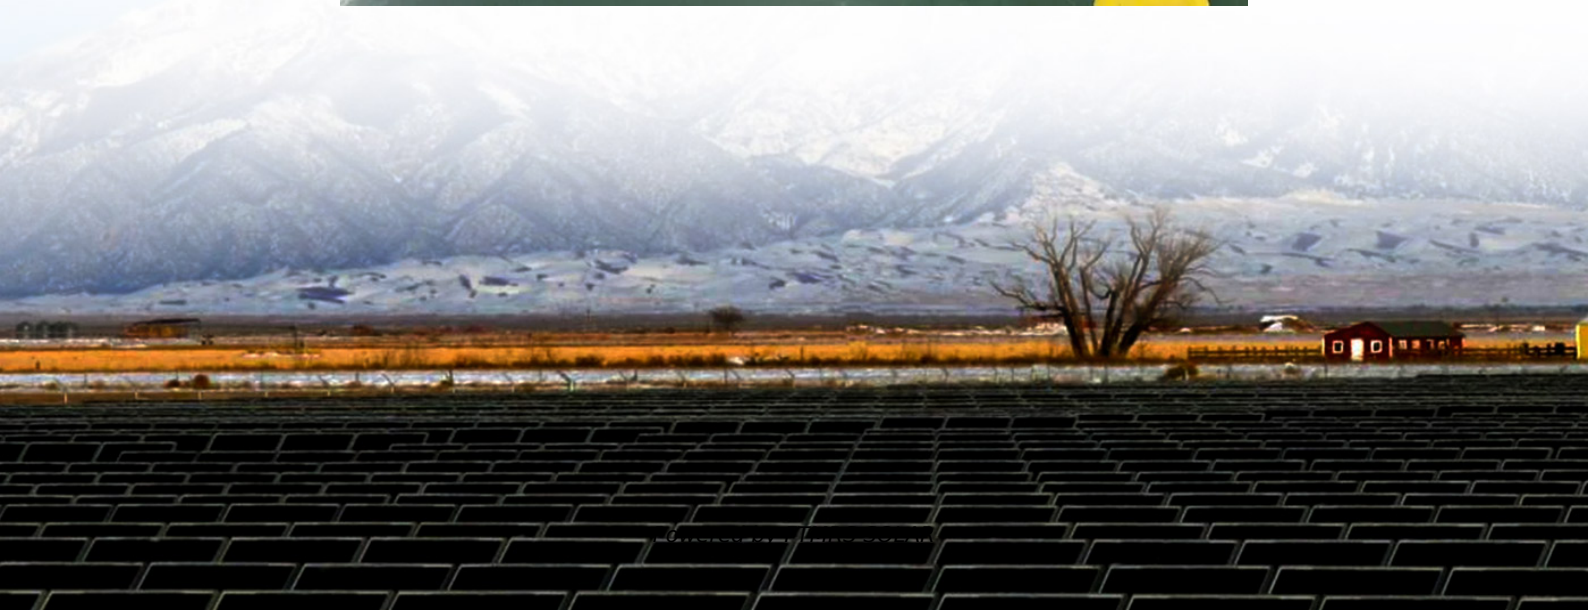
Glass breakage likely developed at scratches or chips on glass surfaces and edges. Some recent studies suggested that glass defects were more prominent in newer modules (less than 4 years of age) as compared to 20 year old modules, which may be attributed to the adoption of thinner glass sheets that are more susceptible to glass breakage .

Studies have found that contact between glass and frames is linked to spontaneous breakage in some PV modules. A recommended solution is using rubbery silicone spacers which maintain separation between the glass and the frame. Many modules already use silicone gaskets, but some designs leave gaps where the glass directly touches the metal frame.
